Manhole Inspection Summary

Manhole # S11EE2002MH

Location Address: **2309 CROSS COUNTRY BLVD**

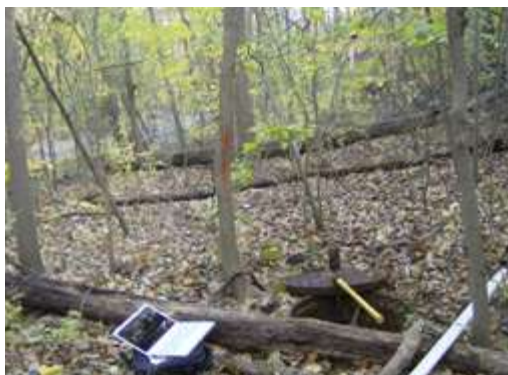
Location View

spray painted tree next to manhole

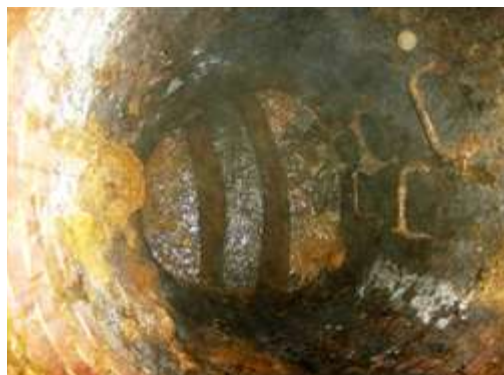
Top View

Corroded steps. Evidence of surcharge - Bench debris.

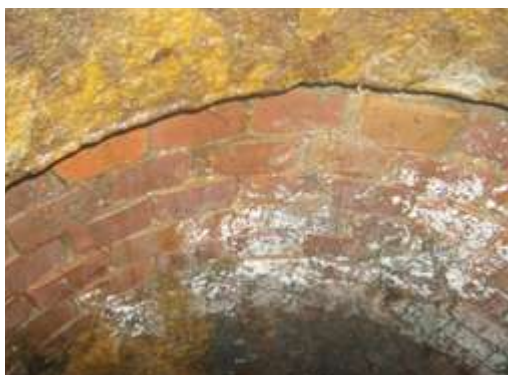
Defect

Frame leaks. Adjustment and Corbel infiltration.

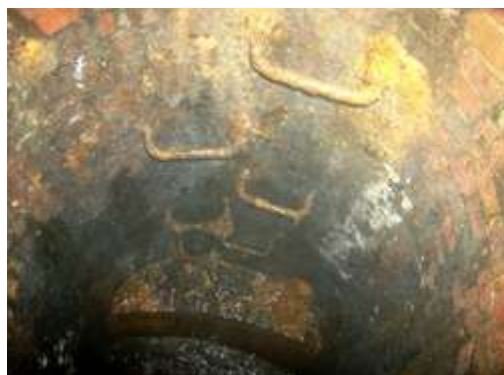
Defect

Adjustment, Corbel and Barrel infiltration.

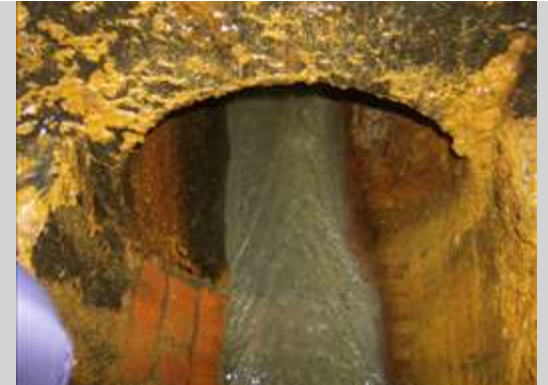
21 in. Circular Gravity Sewer Pipe Out @ 12 O'Clock

Invert Depth: **12.81** (ft.) Flow Characteristics: **Slow**

Infiltration: **None** Pipe Seal Cond: **Unknown**

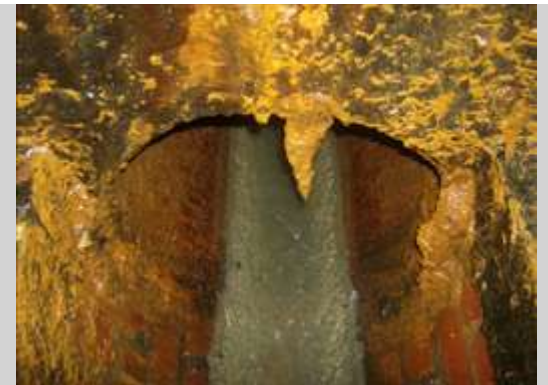
21 in. Circular Gravity Sewer Pipe In @ 6 O'Clock

Invert Depth: **12.63** (ft.) Flow Characteristics: **Slow**

Infiltration: **None** Pipe Seal Cond: **Unknown**
